F-3-76
Springfield Dairy Farm
Lewistown vicinity
Private

F-3-76
Springfield Dairy Farm
Lewistown
Frederick County

Maryland Historical Trust State Historic Sites Inventory Form

1. Name (indicate preferred name)

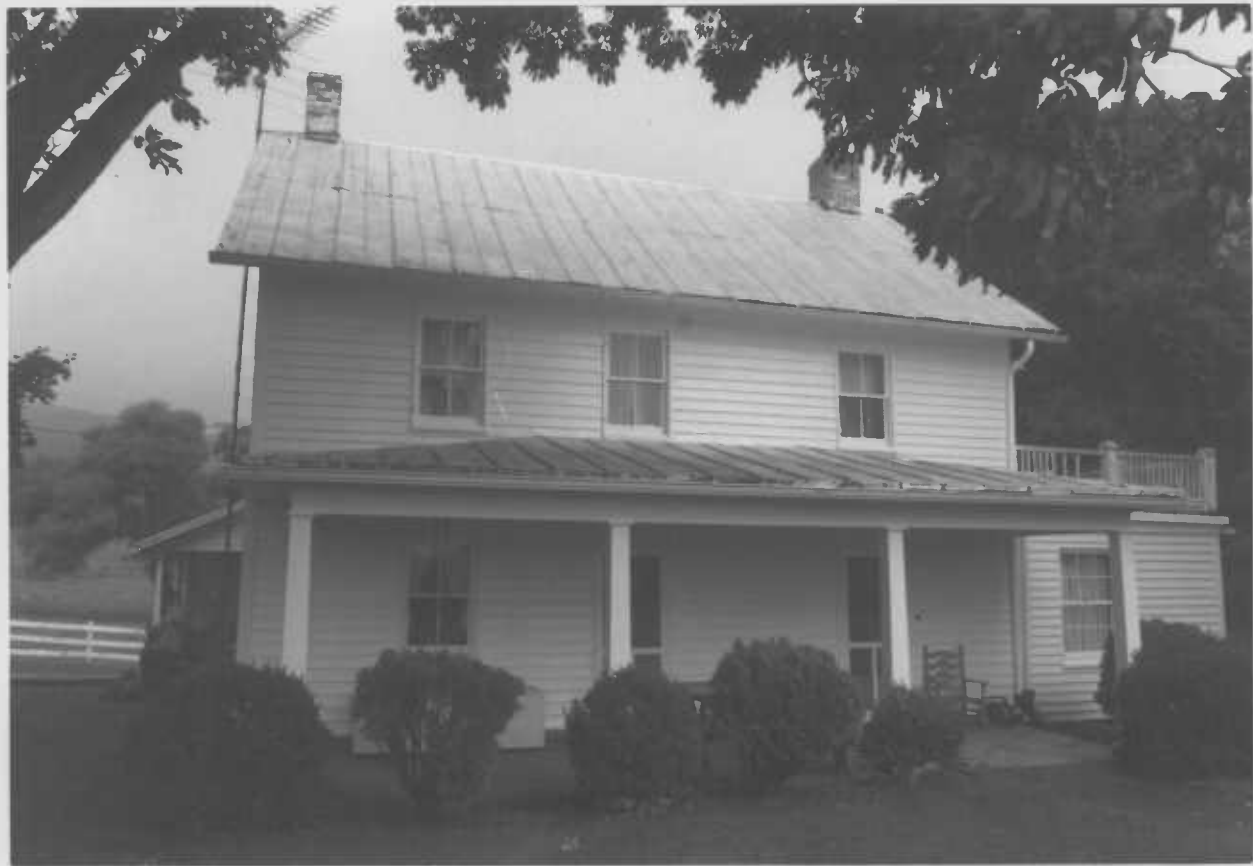
1/6

South elevation

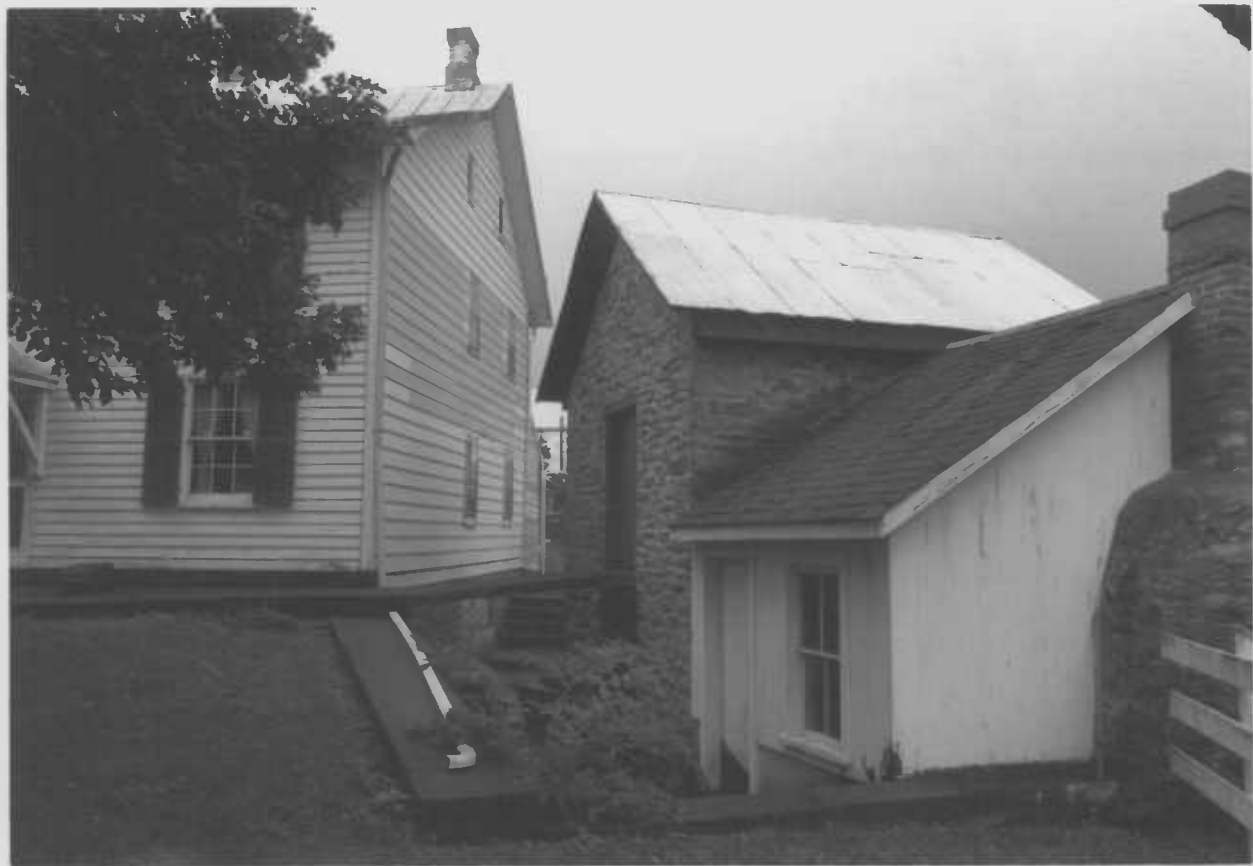
2/6

Springhouse: The two-story stone springhouse has vertical board doors on the south elevation on each level. In the west elevation is a 6/6 window and a beaded board door. The stone walls have been recently repointed. The roof is covered with corrugated metal. On the east elevation is a one-story frame summer kitchen with an exterior stone and brick chimney. The kitchen is covered with vertical siding and the foundation is concrete block. The roof is wood shingles. The south elevation has a vertical board door and a 2/2 window. The springhouse was probably built shortly after the house in the 1820's or early 1830's, based on its rubble stone structure. The summer kitchen may have been added in the early 20th century, as indicated by the concrete block foundation, although the chimney appears to be older.

Springhouse and summer kitchen, view from east

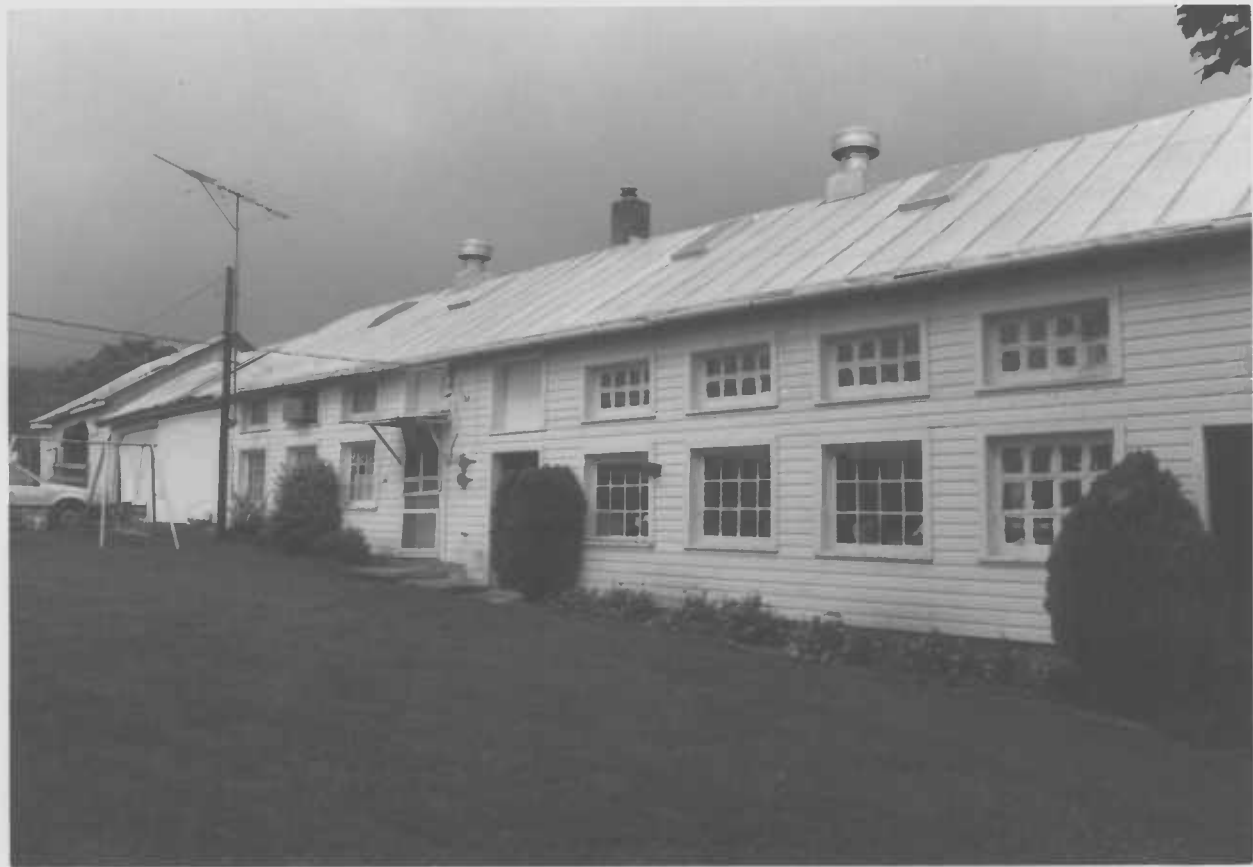
3/6

Chicken house: The chicken house is a 1-1/2 story frame structure located west of the house. Built about 1925-30, based on its materials and size, the chicken house is a long, rectangular building with german siding, and 12-light single sash windows across its south elevation. On the half-story level are small 8-light windows. The western section of the chicken house was converted to an apartment in the mid-20th century. The eastern section is used for storage and a laundry room. The gable roof is standing seam metal. A non-contributing open-front tractor shed attached to the west end of the chicken house links the structure to the wagon shed/corn crib.

Wagon shed/corn crib: The frame wagon shed/corn crib may also date from about 1925. It is unusual in its small size, as compared to other wagon sheds of the early 20th century. It is lower in height and the drive-through is narrow. The exterior is covered with vertical siding and the roof is corrugated metal.

Chicken house and wagon sheds, view from
southeast

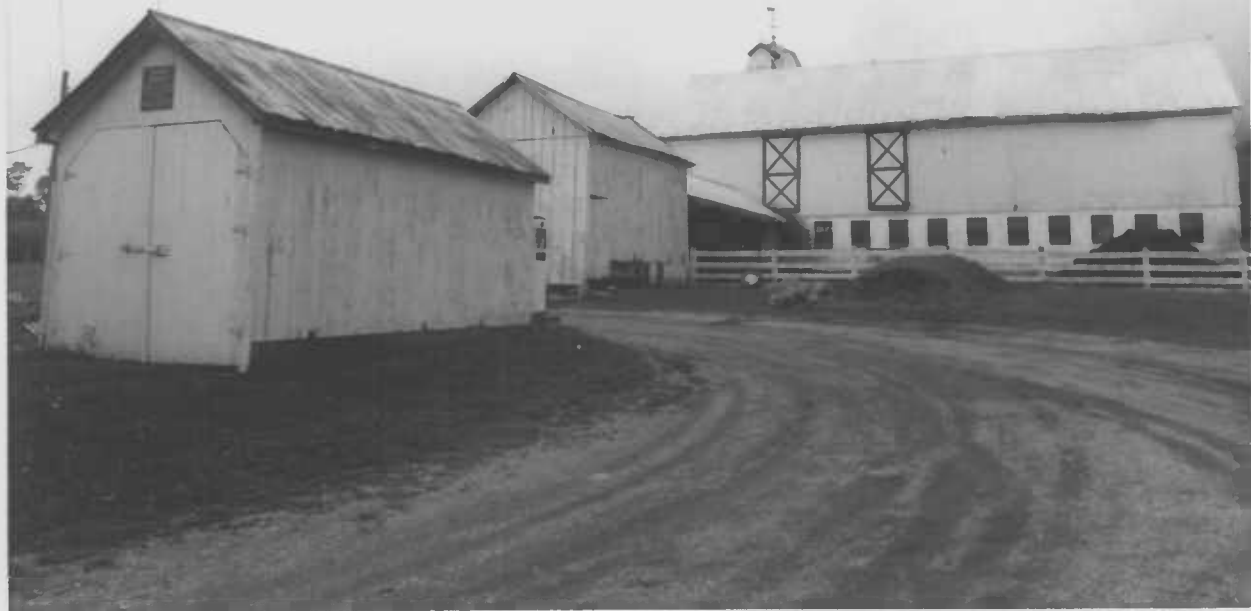
4/6

Garage: The frame garage is a small building located south of the chicken house. Built about 1940, it has a poured concrete foundation, tongue-and-groove siding, and a corrugated metal roof. Double vertical board swing doors are located in the east elevation.

Hog barn: The hog barn is a small frame structure located west of the garage. Now used as a chicken house, the building has vertical board siding with a covered wallow area on the south elevation which has been divided into stalls. The gable roof is covered with corrugated metal. A non-contributing loafing shed on the west elevation links the hog barn to the 1941 barn.

View west toward garage, hog barn, and
dairy barn

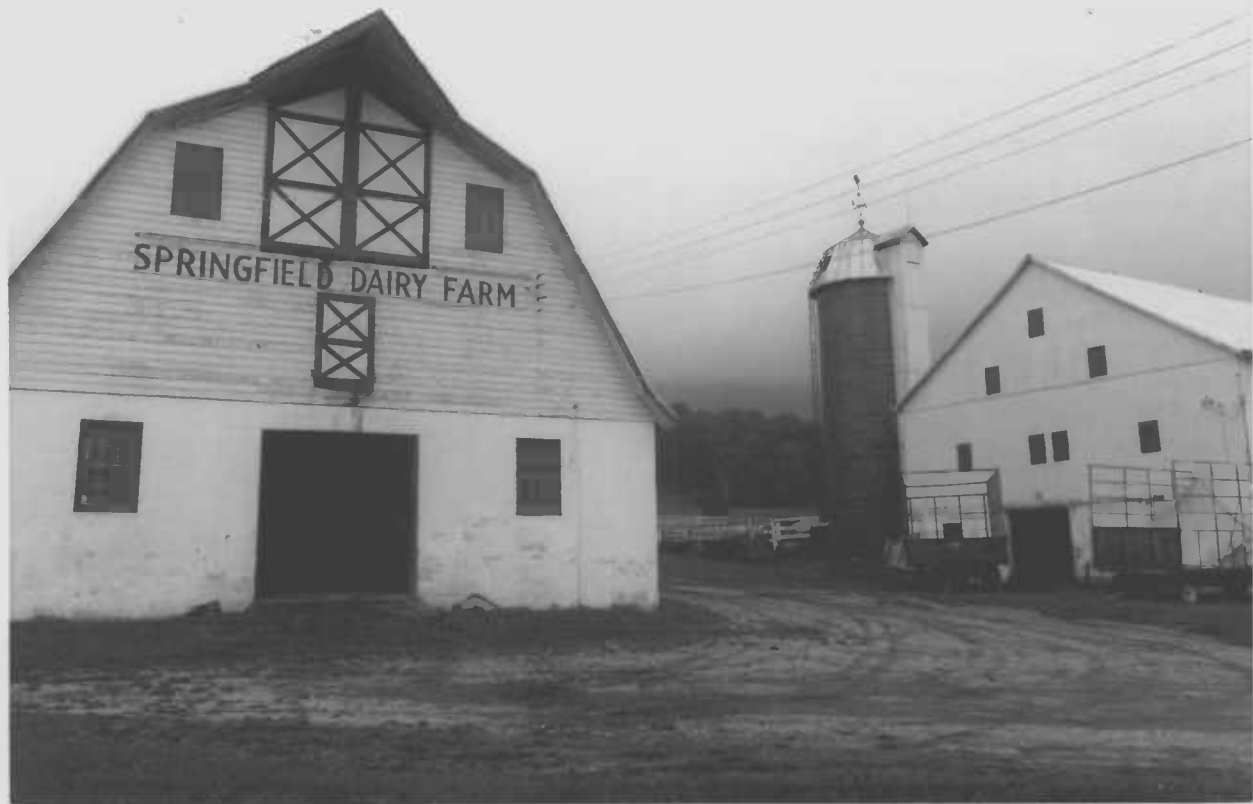
5/6

Barn: The concrete block barn was built about 1941, based on its materials and design. It is located on the site of the original bank barn and has a wide opening on the south elevation. The gable above is covered with tongue-and-groove siding, with louvred vents. The gable roof is covered with corrugated metal. Sliding doors are also located on the west elevation at the ramp.

Terra cotta silo: The terra cotta block silo, built about 1940, is located next to the ramp to the loft of the 1941 barn. It has a standing seam metal cap with an elaborate weathervane with a cow motif.

Dairy barns and terra cotta silo, view from
east

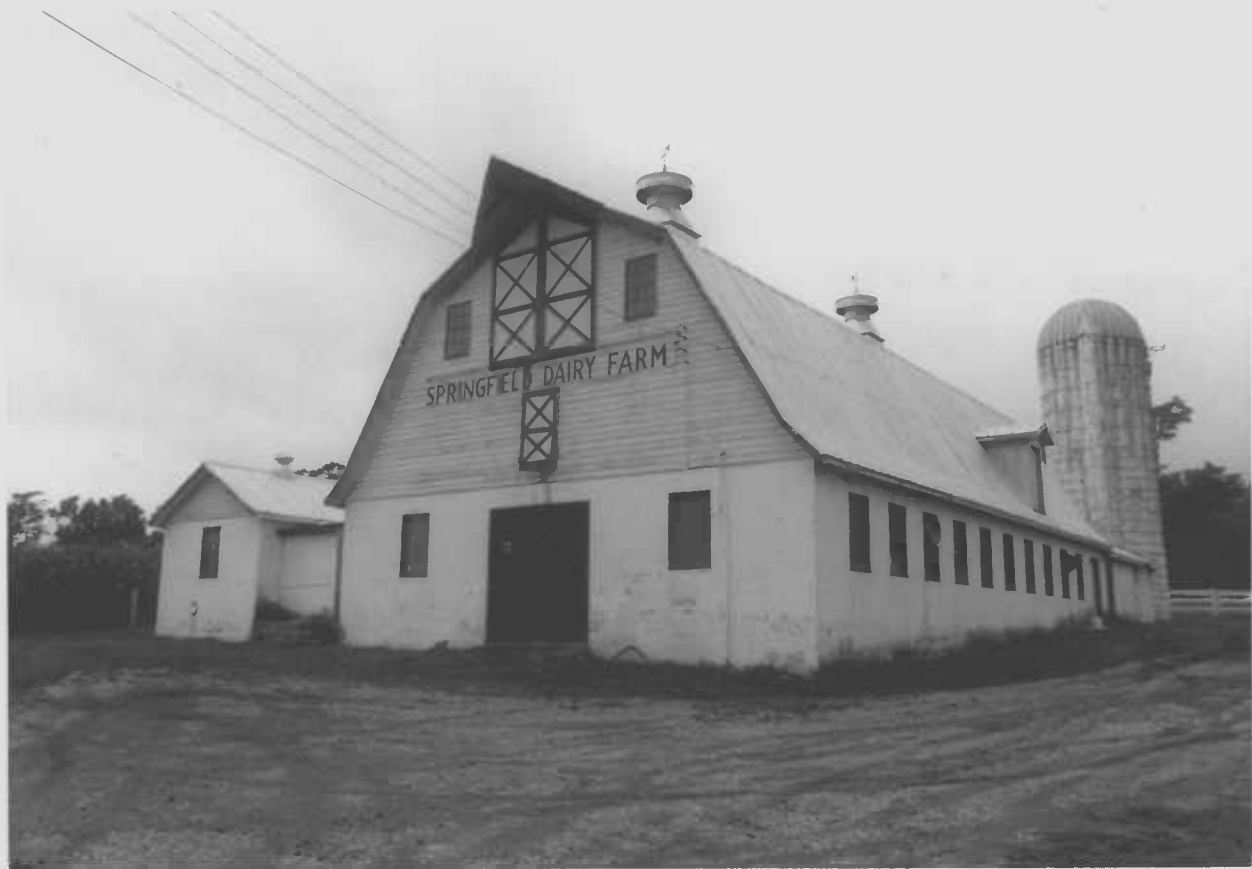
Non-contributing dairy barn: The gambrel-roofed concrete block dairy barn was probably built after 1945 and is located at the southernmost side of the farmstead with a matching milk house. Painted across the german siding of the east gable end is the name "Springfield Dairy Farm", by which the farmstead is most easily identified.

Dairy barn and milk house, north east corner view
6/6
